Washington Briefing
Deepwater Horizon Interim Incident Investigation

24th May 2010

Macondo Well Diagram – Key Components & Critical Factors

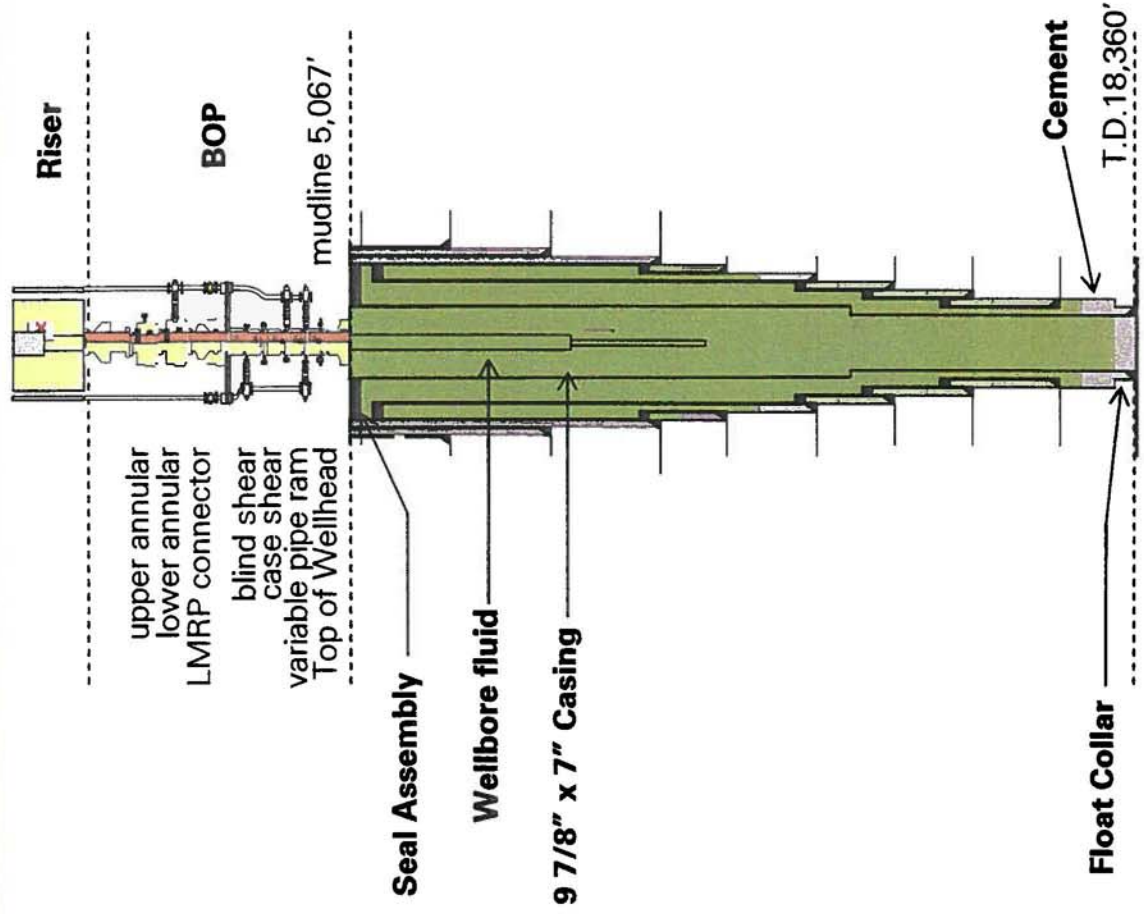
1. Loss of Integrity of the 9 7/8" x 7" casing created a path for hydrocarbon (HC) influx
2. Unrecognized well conditions
 - Influx unrecognized - Integrity test failed to identify communication with the reservoir
 - Operations allowed HC influx to enter and move up the well bore – well became capable of flowing
 - Response failed to control the well
3. BOP & Emergency Systems failed to isolate the HC source
4. Gas plume ignited

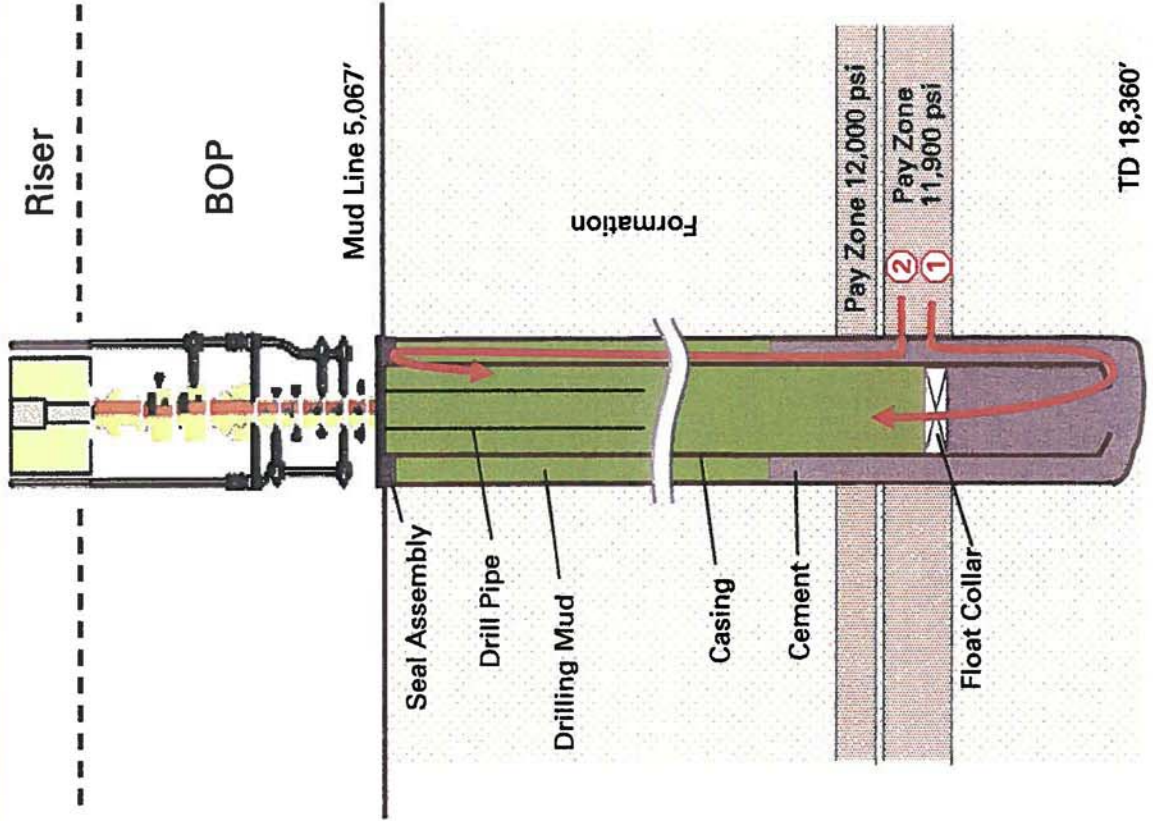
Critical Factor 1 – Loss of Integrity of Casing

- Cement failed to isolate the reservoir
- The float collar (1) or the seal assembly (2) leaked

- Review design and execution of the cement job
- Review design and installation of casing shoe track and seal assembly
- Laboratory testing of float collar
- Detailed well dynamic modeling to assess likely influx point

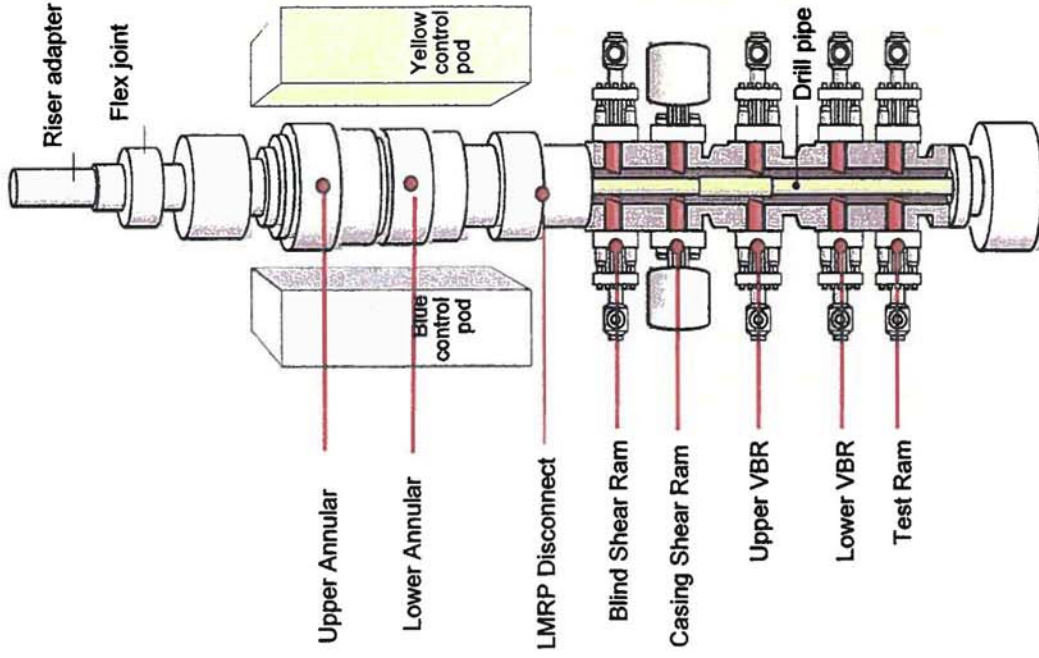
Critical Factor 3 – BOP Failed to Isolate Source

- Action to activate the BOP once well condition was recognized failed to isolate the source
- EDS failed to secure the well (when activated from bridge after explosion)
- AMF/Dead-man failed to secure well
- Subsequent ROV interventions failed to secure the well

- Understand BOP testing history and performance of emergency systems, EDS, Auto shear, AMF (Deadman), ROV hot stab
- Understanding of BOP modifications – could they have affected its functionality?
- Assess leaks identified during ROV intervention and determine significance – could they have affected its functionality?
- Evaluation of BOP maintenance history regards system completeness, OEM parts and 3rd party services
- Inspect & test BOP once retrieved from sea floor

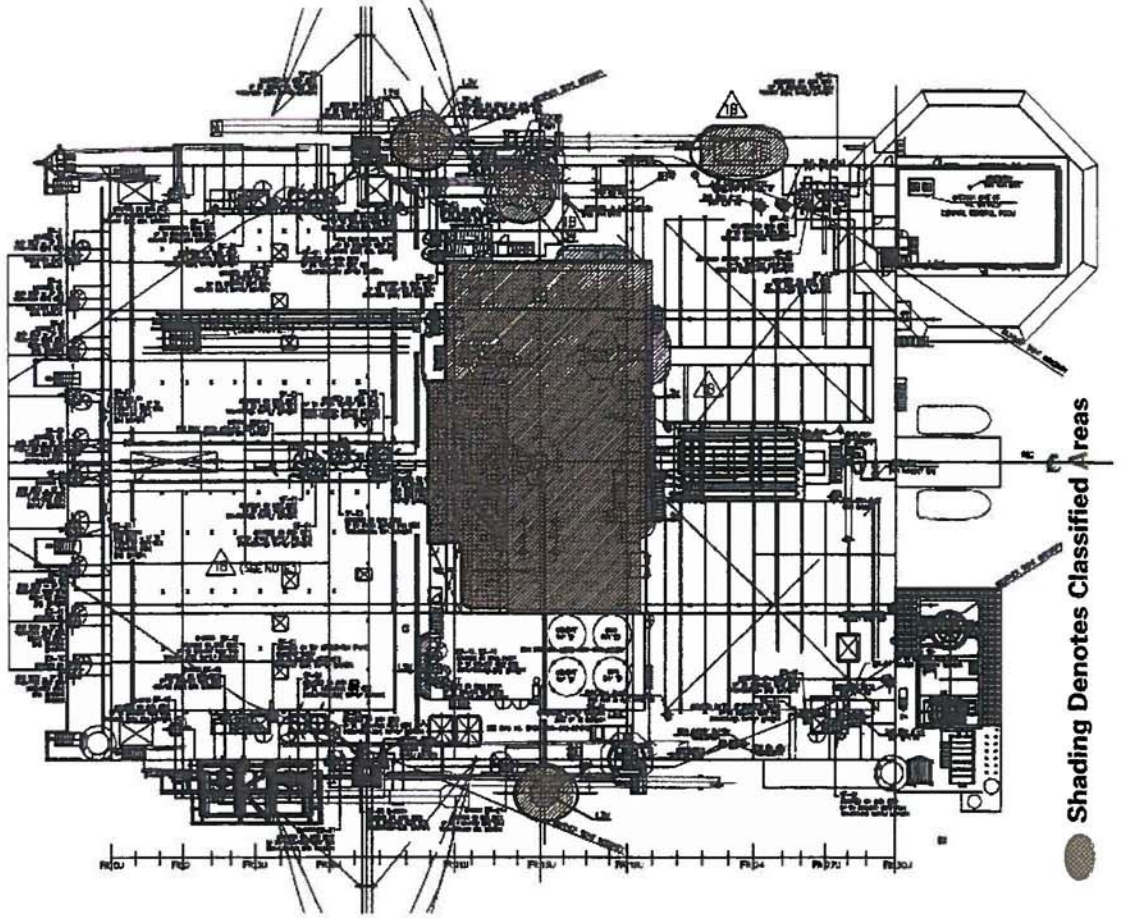
Hazardous Area Classification - Main Deck

- Hydrocarbon gas detected by several gas detectors prior to explosion (two witness statements from bridge).
- Several potential scenarios of hydrocarbon release to atmosphere have been identified.
- Dynamic modeling estimates suggests that flammable gas mixtures could have reached non-electrically classified areas.

- Fluid dynamic modeling being further developed in-line with most probable release scenarios.
 - Access to pit room / mud pumps
 - Access to derrick via degasser
 - Access to engine room
- Review of electrical area classification, fire and gas design and ventilation system design.

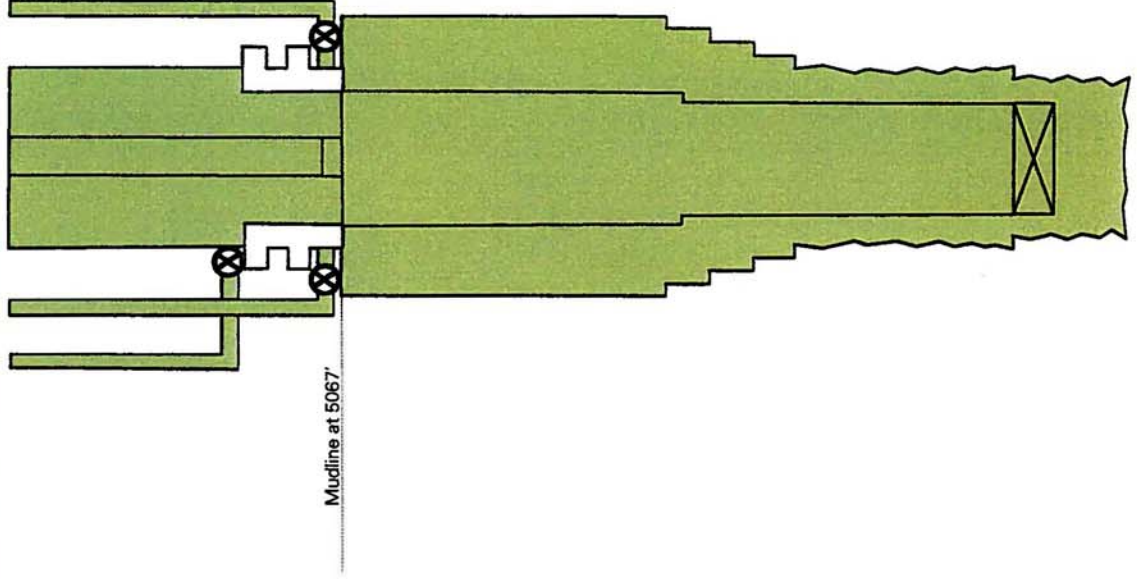
Run Casing – Convert Float Equipment

- Run 7" x 9-7/8' production casing
 - Crossover at 12487'
 - Float Collar at 18114'
 - Shoe at 18304'
 - 56' of rat hole
- Laid out three joints of 7" due to damaged threads
- Saw 10k weight bobble at 18218 (only time string took weight during run)
- 9 attempts to convert float equipment
 - Sheared at 3142 psi vs 500-700 psi design

- Circulating pressure below normal after shearing float collar

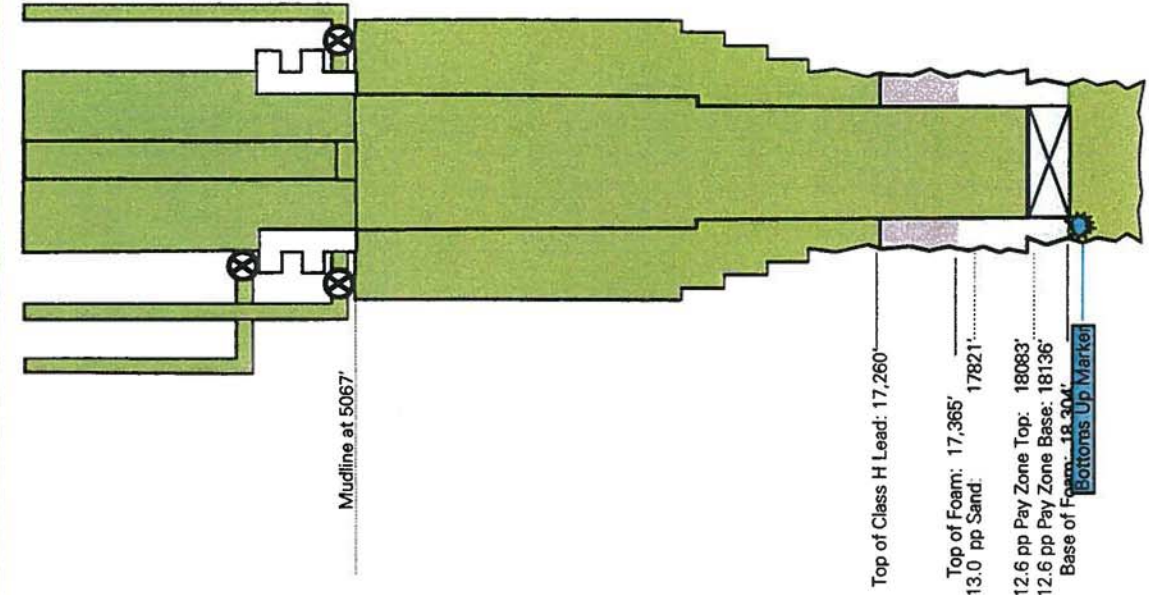
Cement Job

- Circulate 342 bbl before cement job
- Pump nitrified foam cement
 - Pumped 60 bbl cement
- Estimated TOC at 17260'
- Bumped plug with 1150 psi
 - Cement in place at 00:35
 - Bled back 5 bbls to 0 psi
 - Minimal calculated U-tube pressure after job (nearly balanced)
- 14.0 ppg mud in rathole with 16.7 ppg cement in shoe track

- Job pumped per plan – no cement losses observed
- Minimal U-tube may have prevented definitive float test
- Potential for contamination of cement in shoe track due to density difference between cement and mud

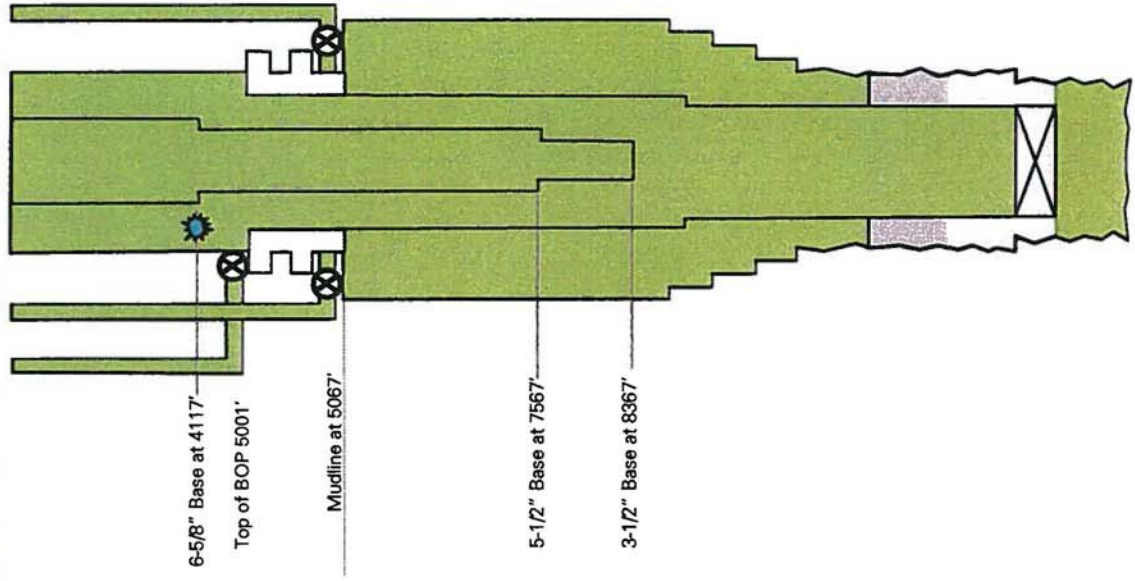
Finish Trip in Hole

- The approach to transferring mud may have impaired pit monitoring over next 4 hours

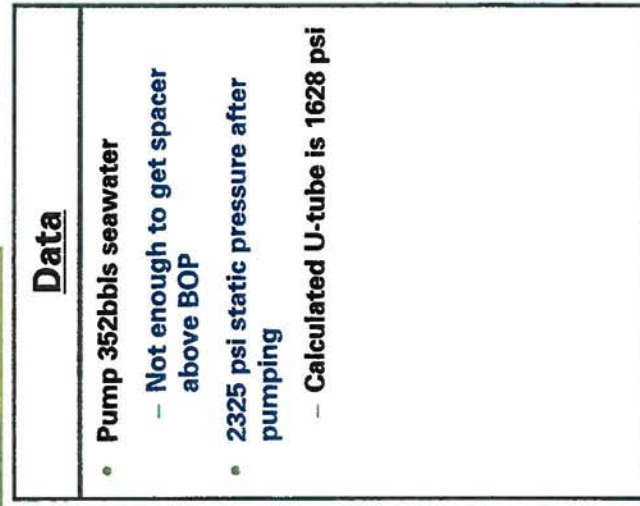
Pump Seawater

- Pump 352bbbls seawater
 - Not enough to get spacer above BOP
- 2325 psi static pressure after pumping
 - Calculated U-tube is 1628 psi

- Higher than expected static pressure may indicate large spacer-to-water interface
- Significant solids settling expected once pumps stop
- High gel strength with 100% spacer

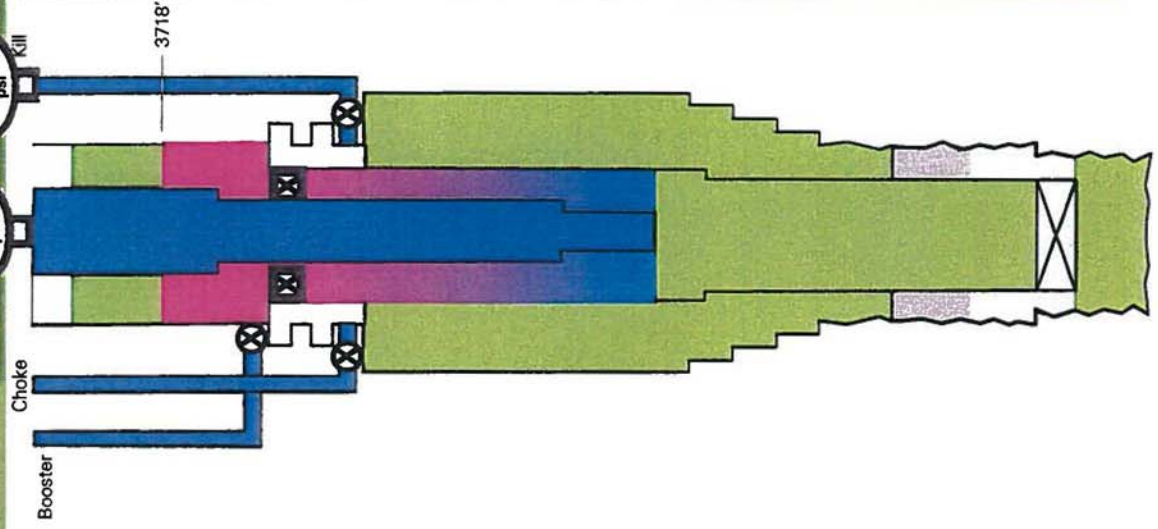
Bleed to 273 psi

- Open kill line
- Pressure equalizes
 - Drillpipe pressure goes to 1400 psi
 - Kill line pressure drops to 645 psi
- Bleed pressure to 273 psi on drillpipe as kill line pressure drops to zero
 - DP pressure never gets to zero
- First time well is under balance
- Observed that fluid level in the riser had dropped

- U-tube between drill pipe and kill line due to heavy fluid in the annulus
- Suspect the annular is leaking

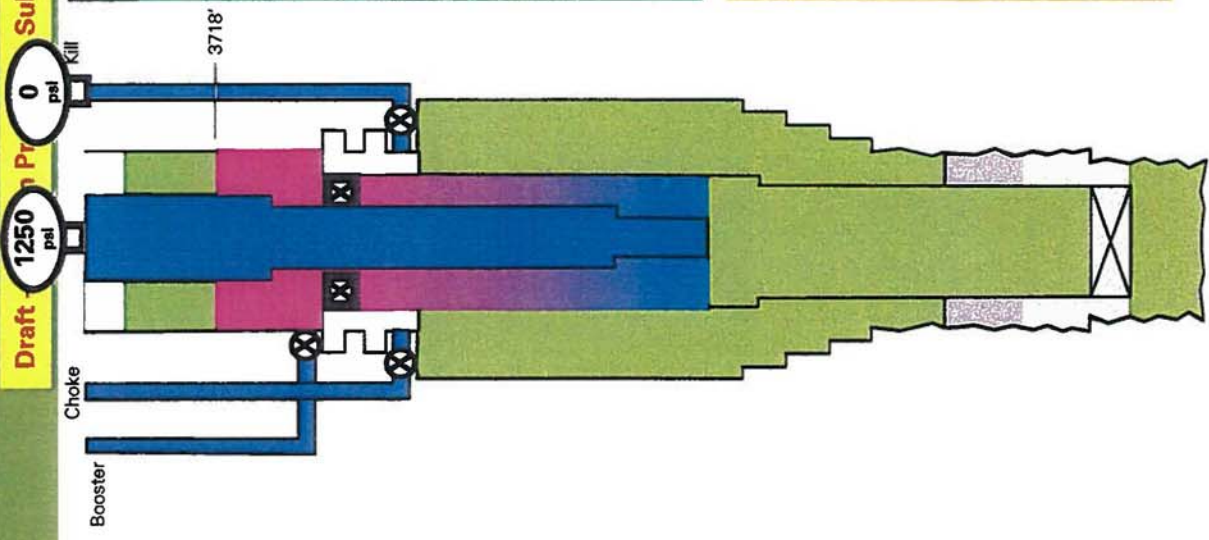
Drillpipe Pressure Builds / Fill Riser

- Shut in drillpipe
- Pressure builds to 1250 psi in 6 minutes
- Filled the riser with 50bbbls from trip tank
- Mud offload to Bankston ends at 17:17
 - Mudloggers not informed that offloading had ceased

- If the annular was leaking it is now sealed
- Discussion on rig floor about pressure on drillpipe
 - Decision made to conduct negative test on kill line

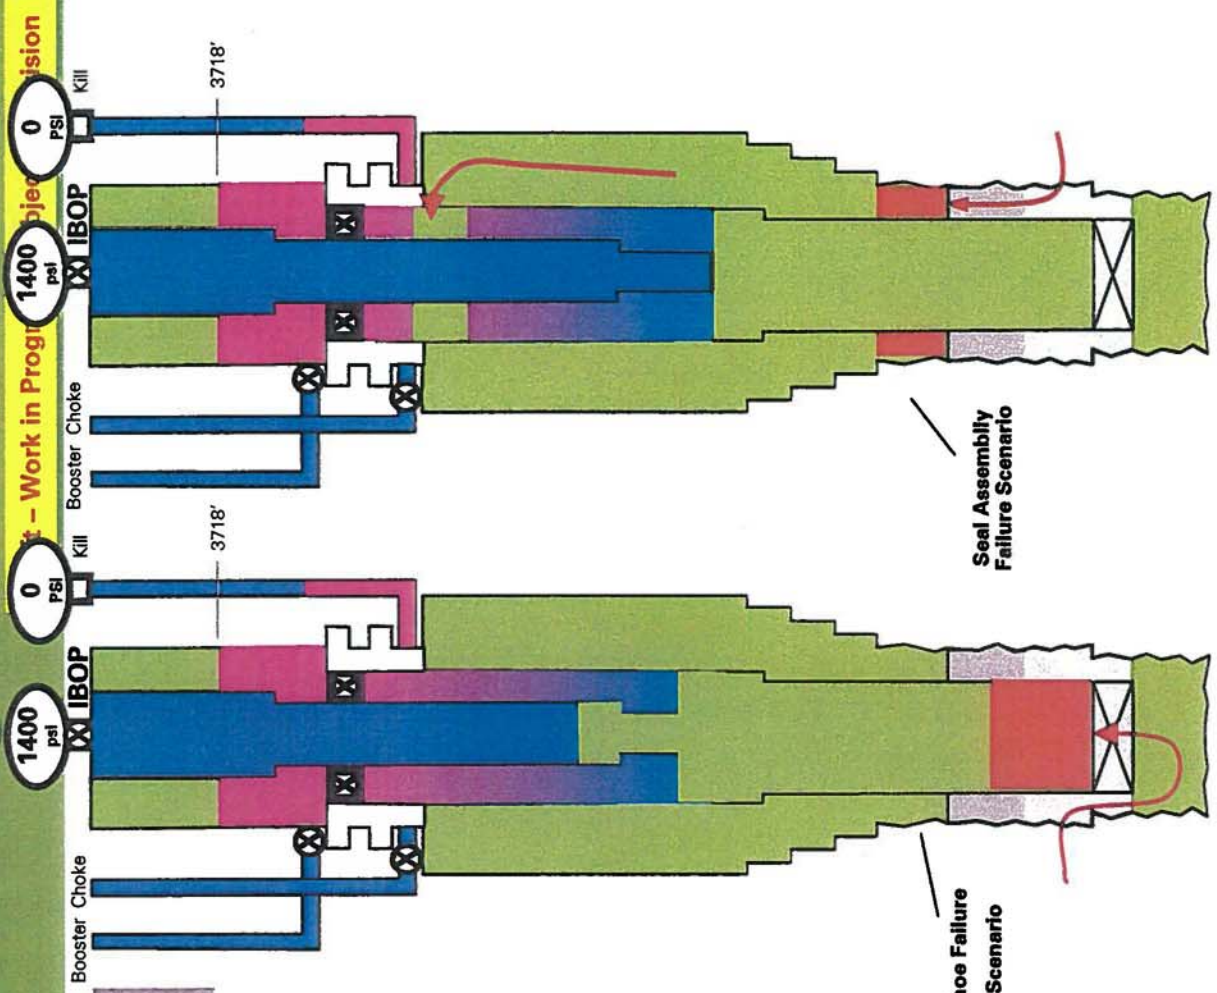
Pressure Holds – Negative Test

Data	
•	Drillpipe pressure (monitored at Halliburton) stays steady at 1400 psi
•	Pumped on kill line to ensure full
•	Bled off 0.2 bbls to trip tank
•	Monitored kill line for 30 minutes
•	Prepare to displace with seawater

Interpretation	
•	Discussion about pressure on the drillpipe
•	No flow observed on kill line
•	Rig team satisfied that test successful

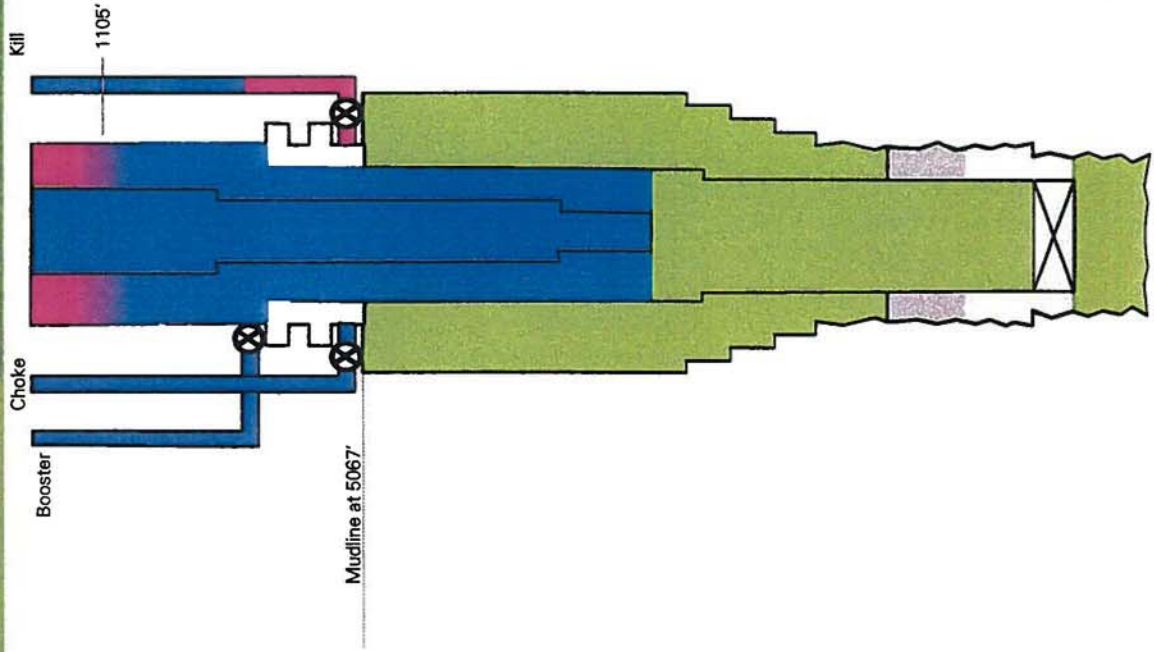
Displace to Seawater

- Pumped 1304 bbl seawater
 - Using rig pumps and booster
- Shut down for sheen test – spacer back
 - 1017 psi on DP when shut down
- Sheen test passes
- Crew instructed to divert returns overboard

- Flow out greater than flow in commencing at 20:58 while slowing pumps for spacer return
- Second indication of flow at 21:08 when pumps shutdown for sheen test
 - Pressure builds to 1263 over 5.5 minute period
 - Flow meter indicates well flowing

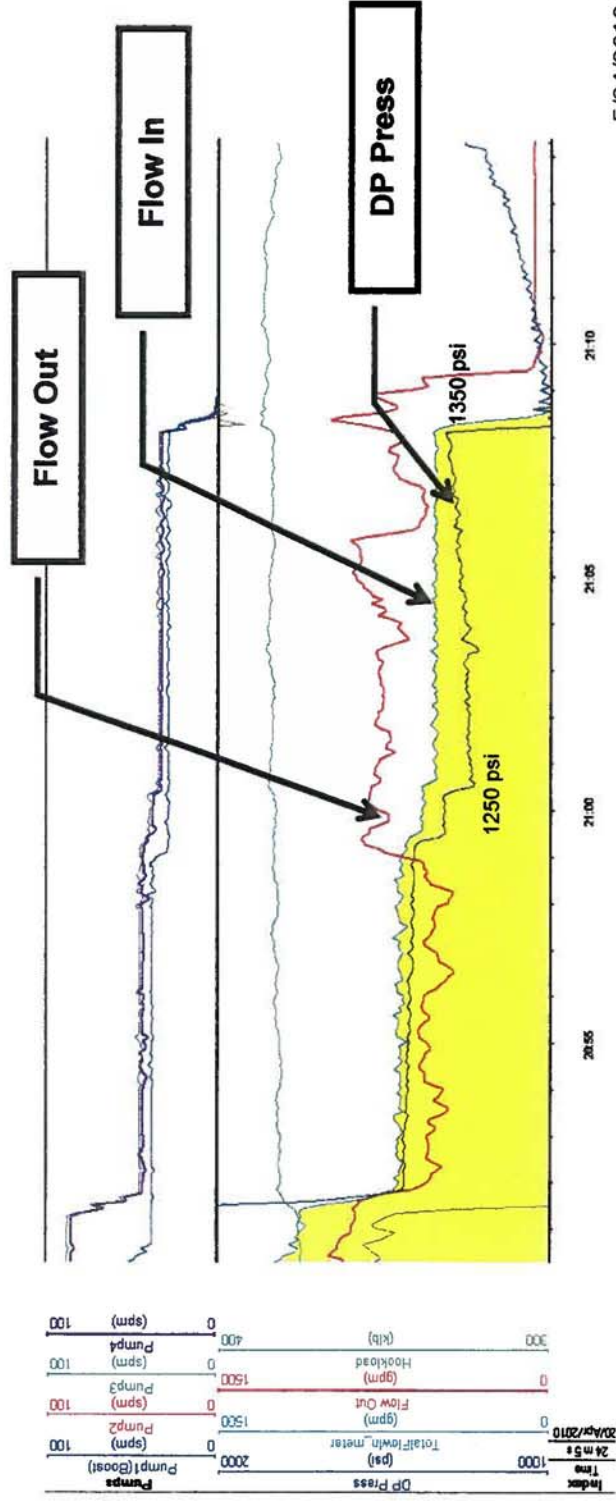
Critical Factor 2: Flow Indication #1 51 minutes before explosion

- Following final integrity test of wellbore, BOP annular was opened and well displacement of mud to seawater began:
 - Flow-out volume of mud and drillpipe pressure showed expected correlation until about 20:58
 - At 20:58, pumps were slowed and the following abnormal results:
 - Drillpipe pressure increased from 1250 psi to 1350 psi
 - Flow-out volume increased instead of slowing
 - Flow-out vs flow-in shows gain of approx 57 bbls over 12 minute period
 - First indication of flow ~51 minutes before the explosion

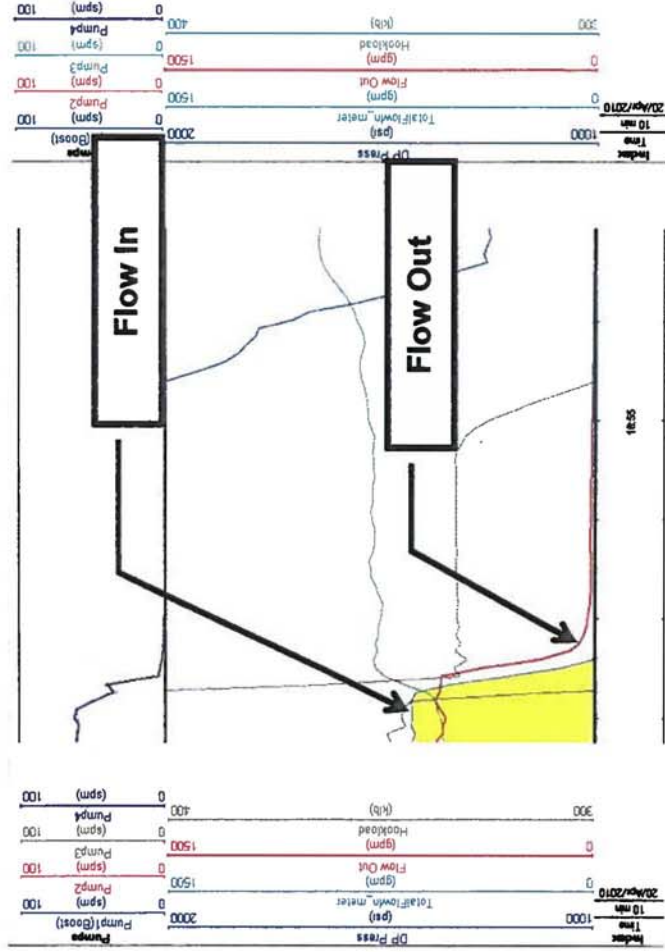
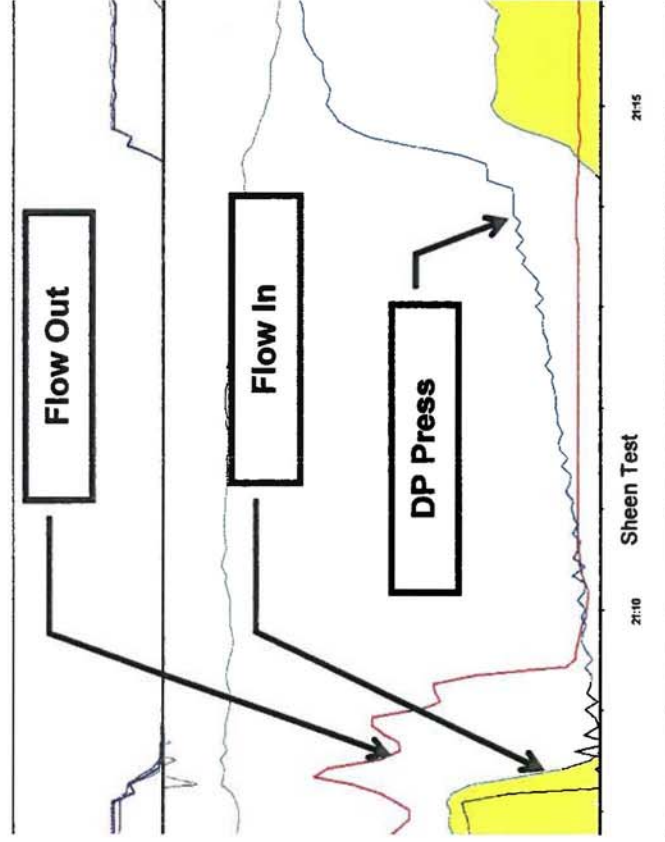
- At 21:08 – pump shutdown as spacer observed at surface. Sheen test required.
 - Flow-out should be zero, but real-time data indicates well flowing after pump shut off
 - Drillpipe pressure increased from 1017 psi to 1263 psi over 5.5 minute period of sheen test

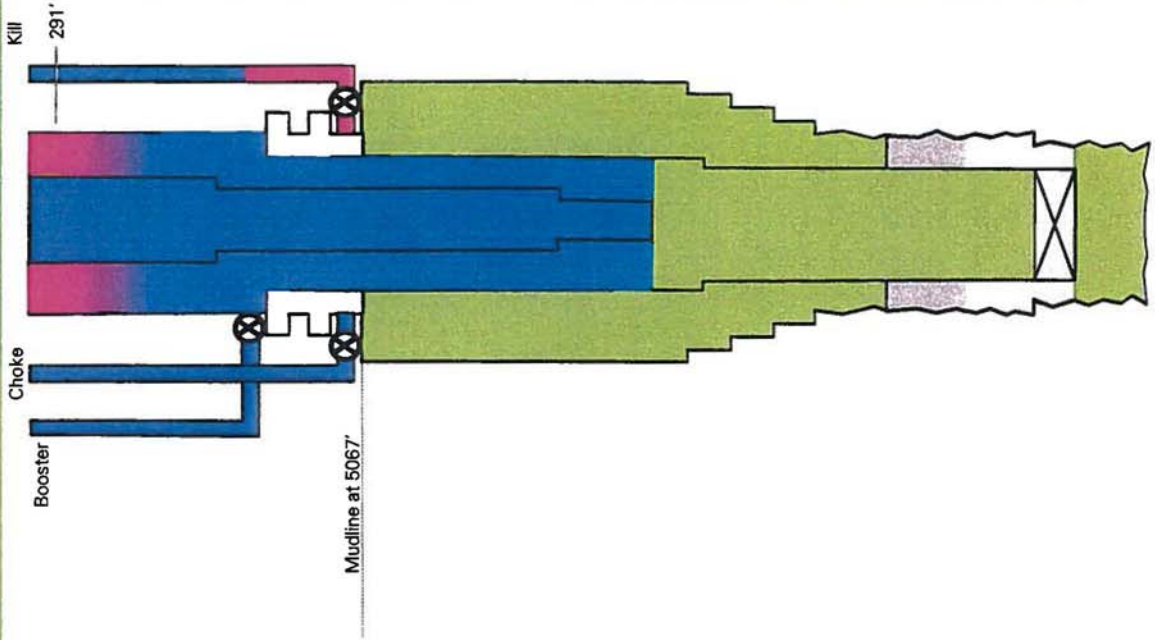
Resume Displacement

- Resume displacement
 - Pump another 265 bbls
 - Returns going overboard
 - Flow meter bypassed – unable to monitor flow out
- Pumps stop at 21:31
- Significant pressure buildup starting at 21:47
- Data lost at 21:49
 - Last pressure reading 5700 psi

- Pumps stop at 21:31 – suspect problem identified with well
- 4 calls made from rig floor and Chief Mate discusses well with Toolpusher on rig floor
- Suspect explosion at 21:49
- EDS at 21:56 by Captain

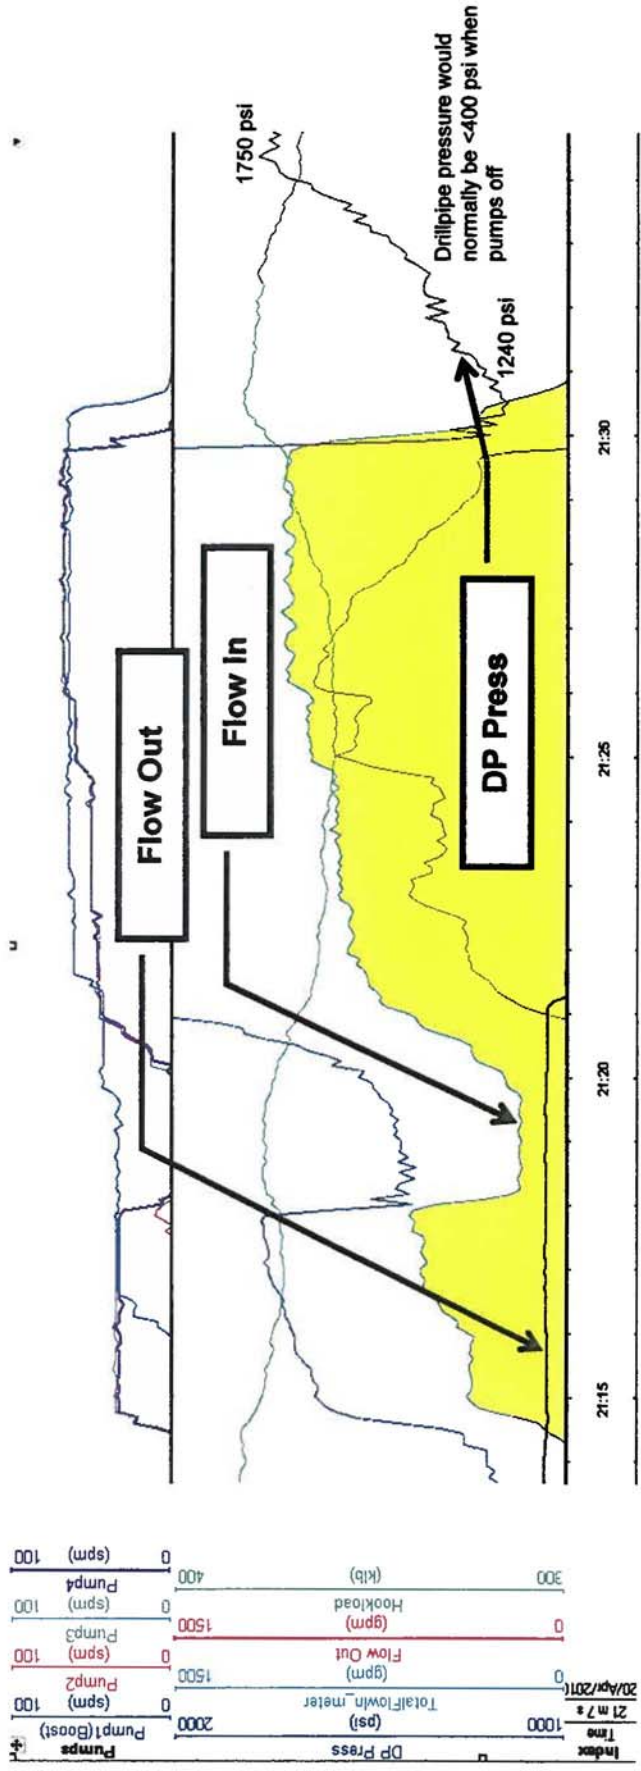
Critical Factor 2: Flow Indication #3 18 minutes before explosion

- Sheen test passed and approval granted to discharge overboard
- At 21:14, pumping resumed to continue displacement to seawater
- At 21:31, problem observed (e.g. mud returns, abnormal pressures)
 - Pump abruptly shutdown
 - Drillpipe pressure at time of shutdown was 1240 psi. Increased to 1750 psi over next 6 minutes.
 - Flow-out data not available due to fluids being discharged directly overboard (bypasses flowmeter)

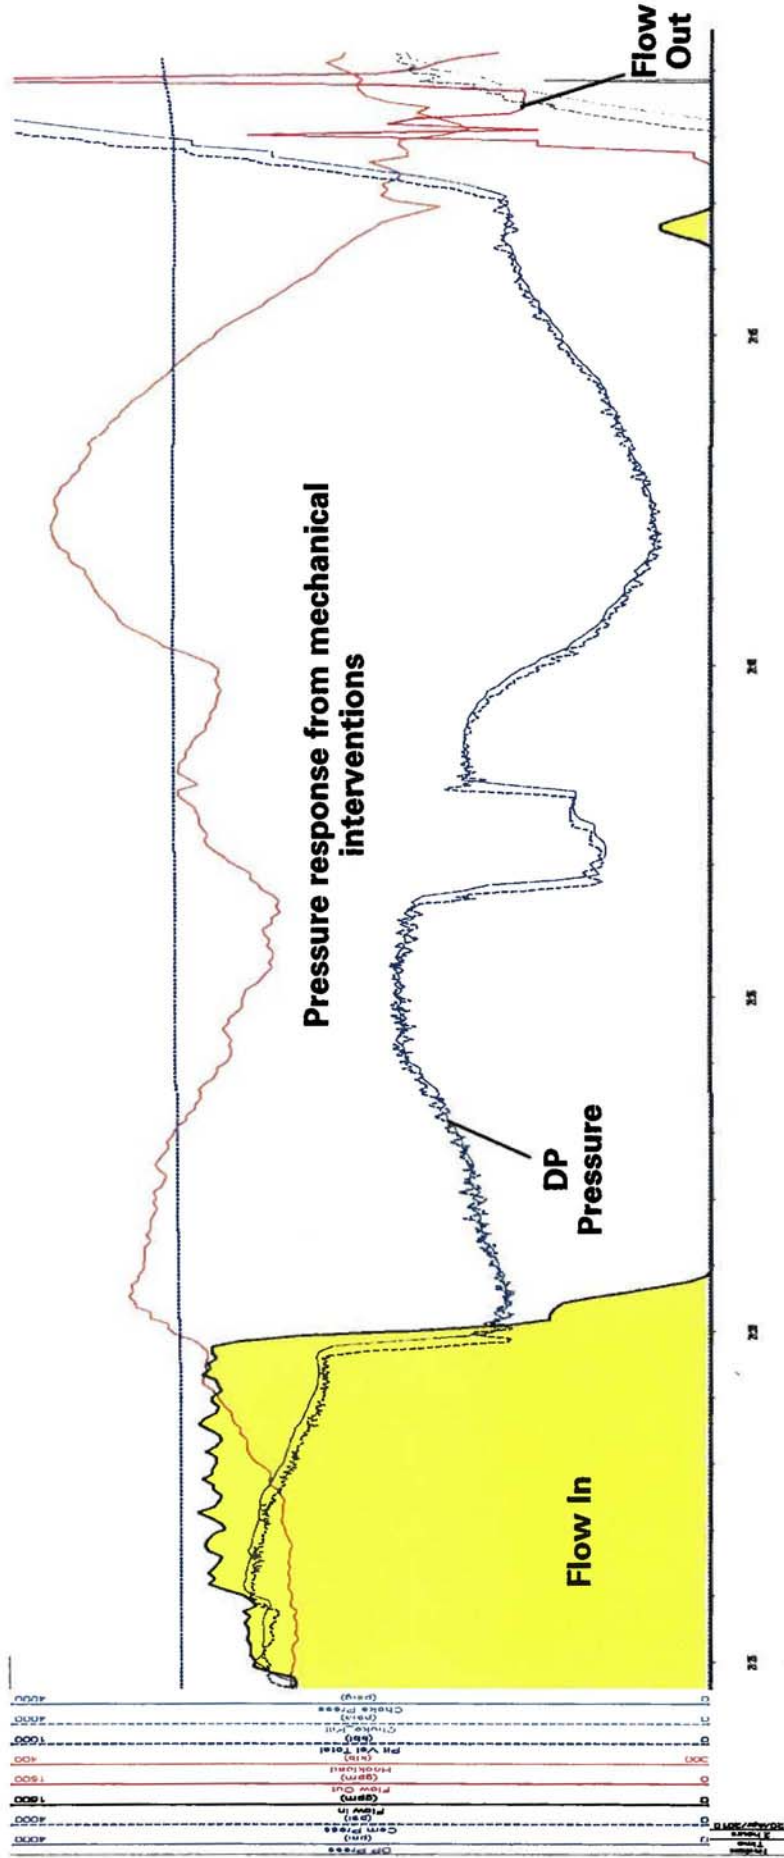
Final 18 Minutes

Data lost,
suspect
explosion
