Washington Briefing
Deepwater Horizon Interim Incident Investigation

24th May 2010

Macondo Well Diagram – Key Components & Critical Factors

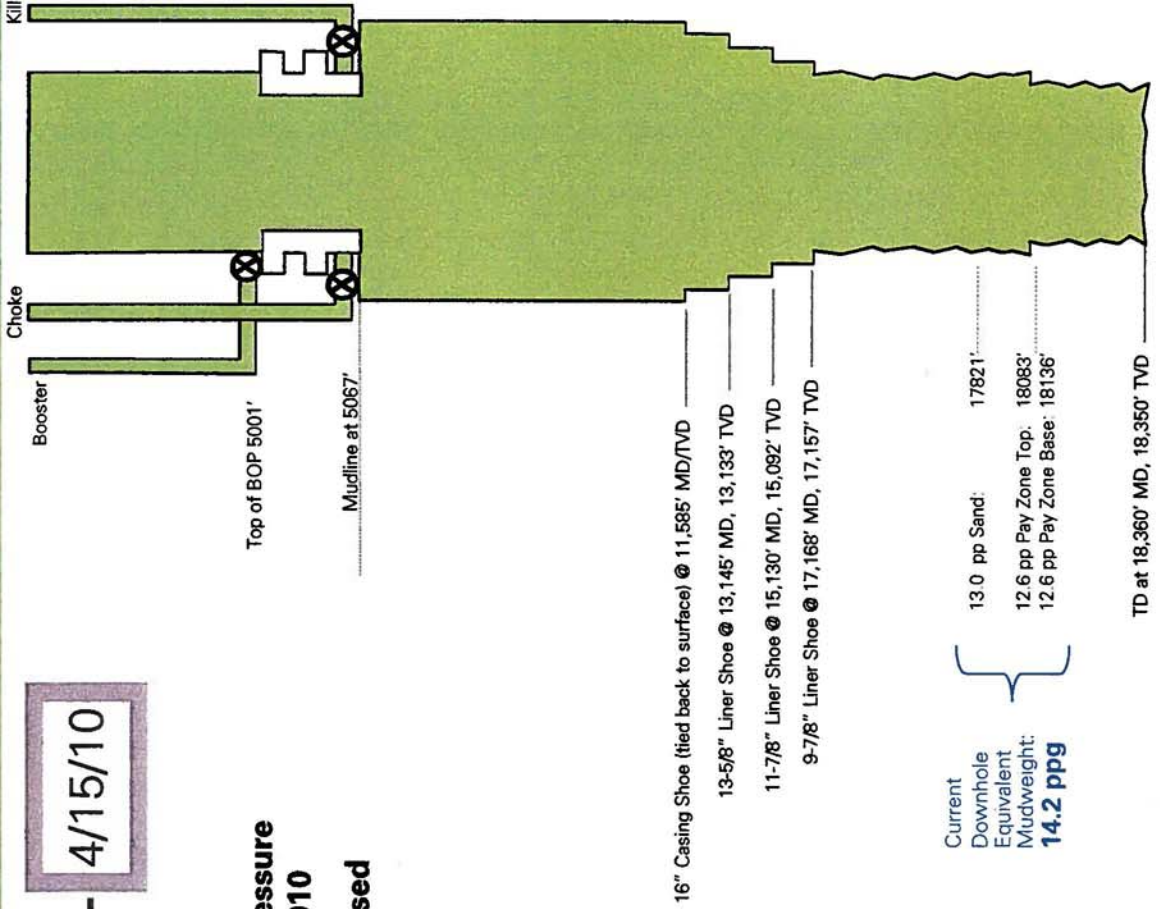
Data
<ul style="list-style-type: none"> Finish drilling <ul style="list-style-type: none"> 9-7/8" x 8-1/2" open hole 14.0 ppg mud inside and out Trip out with drilling assembly Wireline log for 4 days

Interpretation
<ul style="list-style-type: none"> Hole stable

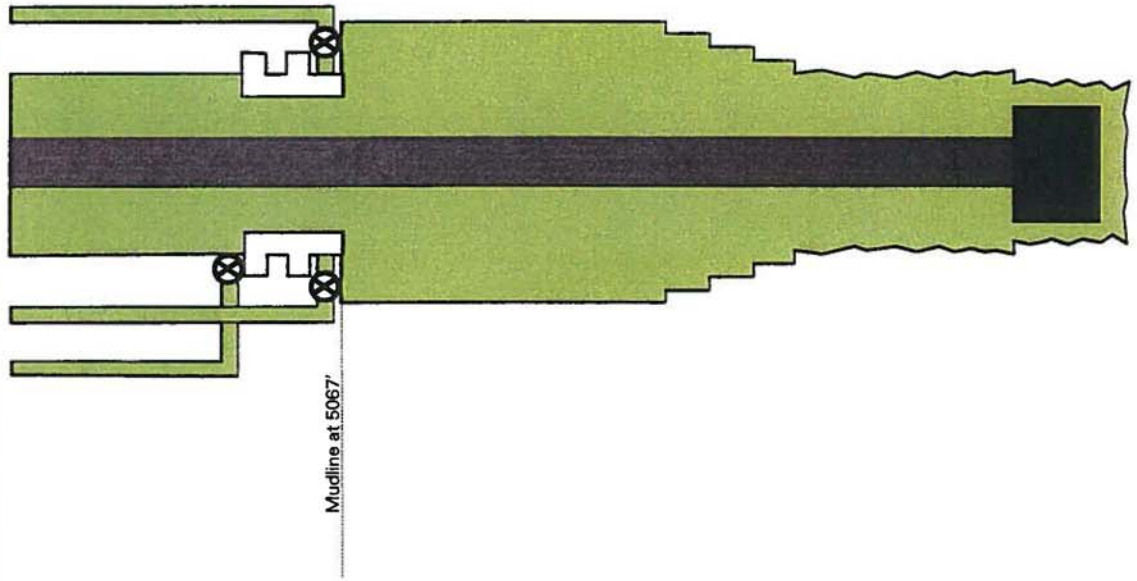
Wiper Trip

Function test BOP:
4/17/10 at 01:00
Function test diverter:
4/17/10 at 01:30

<u>Data</u>
<ul style="list-style-type: none"> • Run in hole for wiper trip <ul style="list-style-type: none"> – Circulate bottoms up at TD – Pump high vis sweep – Monitor for gains or losses – none – 14.0 ppg clean mud throughout before trip out • Pump out from 18360' – 14759' <ul style="list-style-type: none"> – 4 flow checks during trip out – no flow

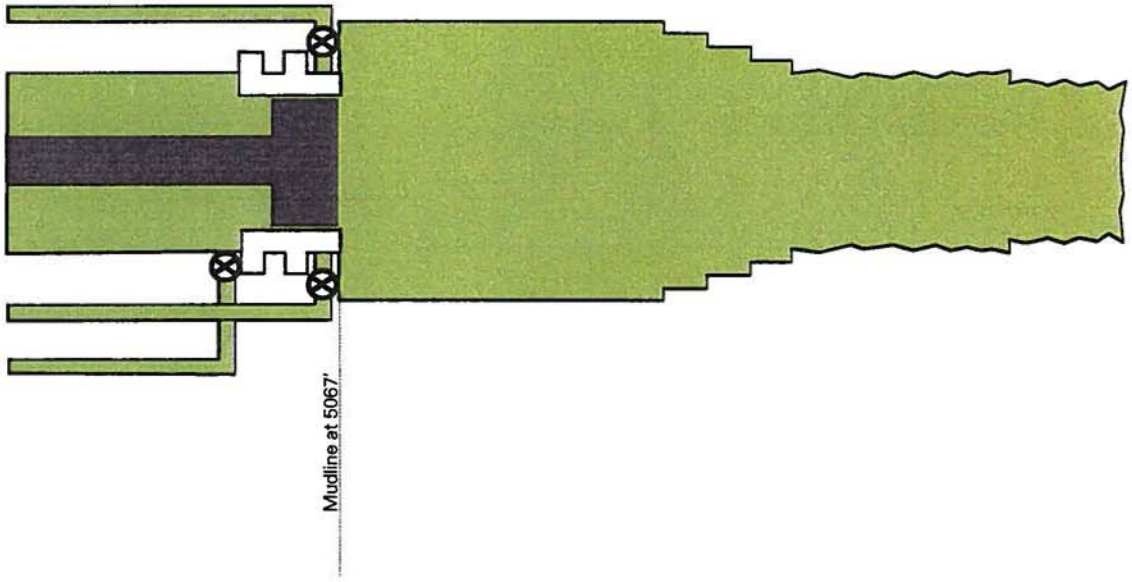
Retrieve Wear Sleeve

Function test BSR
4/17/10 23:00

<u>Data</u>
<ul style="list-style-type: none">• Make trip to retrieve wear sleeve– Retrieval successful

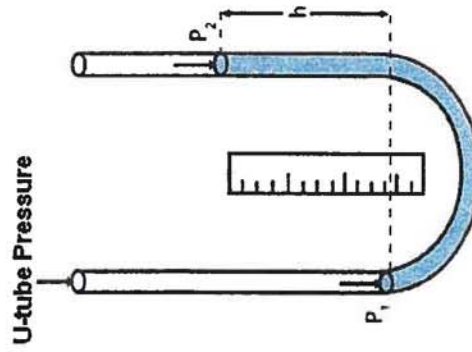
Cement Job

- Circulate 342 bbl before cement job
- Pump nitrified foam cement
 - Pumped 60 bbl cement
- Estimated TOC at 17260'
- Bumped plug with 1150 psi
 - Cement in place at 00:35
 - Bled back 5 bbls to 0 psi
 - Minimal calculated U-tube pressure after job (nearly balanced)
- 14.0 ppg mud in rathole with 16.7 ppg cement in shoe track

- Job pumped per plan – no cement losses observed
- Minimal U-tube may have prevented definitive float test
- Potential for contamination of cement in shoe track due to density difference between cement and mud

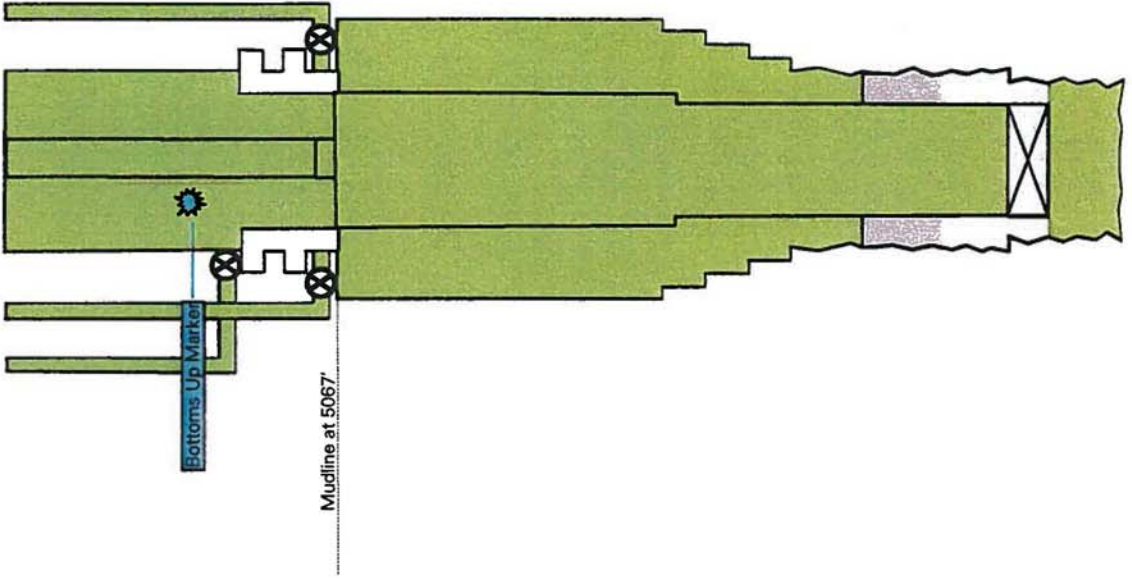
Set Seal Assembly - Lay Down Landing String

Close Upper VBR's to test seal assembly.
Test successful

<u>Data</u>
<ul style="list-style-type: none"> • Release running tool • Set seal assembly at 5059' to seal the 9-7/8" casing annulus • Successful pressure test of seal assembly • Setting and testing procedure as per plan • Begin tripping out

<u>Interpretation</u>
<ul style="list-style-type: none"> • Set and test of seal assembly is normal

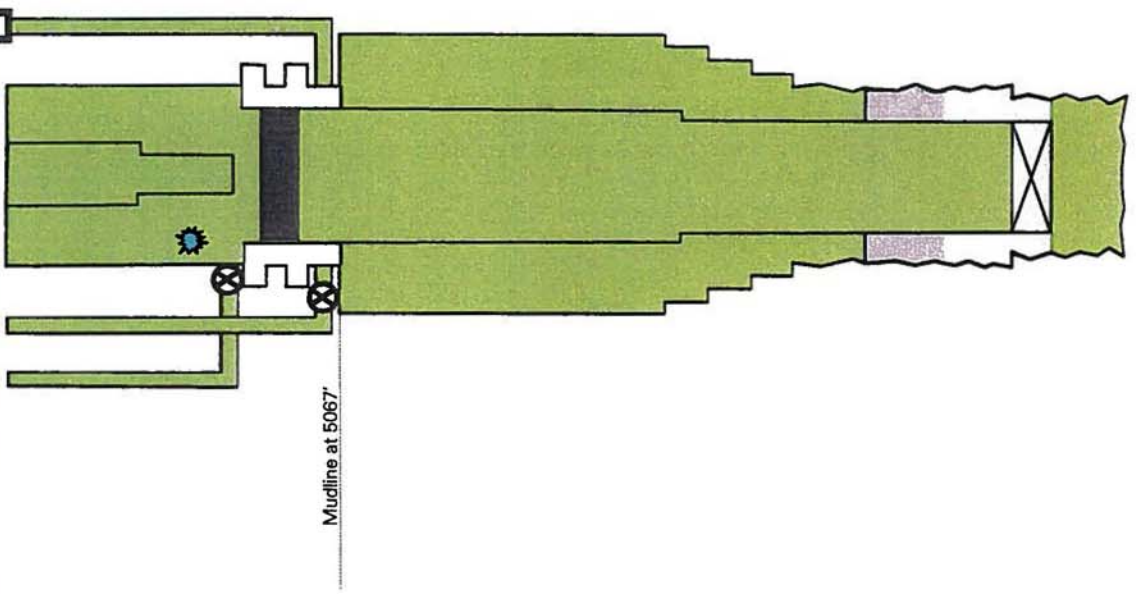
Trip in and Casing Test

12:00 – Close BSR. Pump down kill line to test casing to 250/2500 psi for 30 min

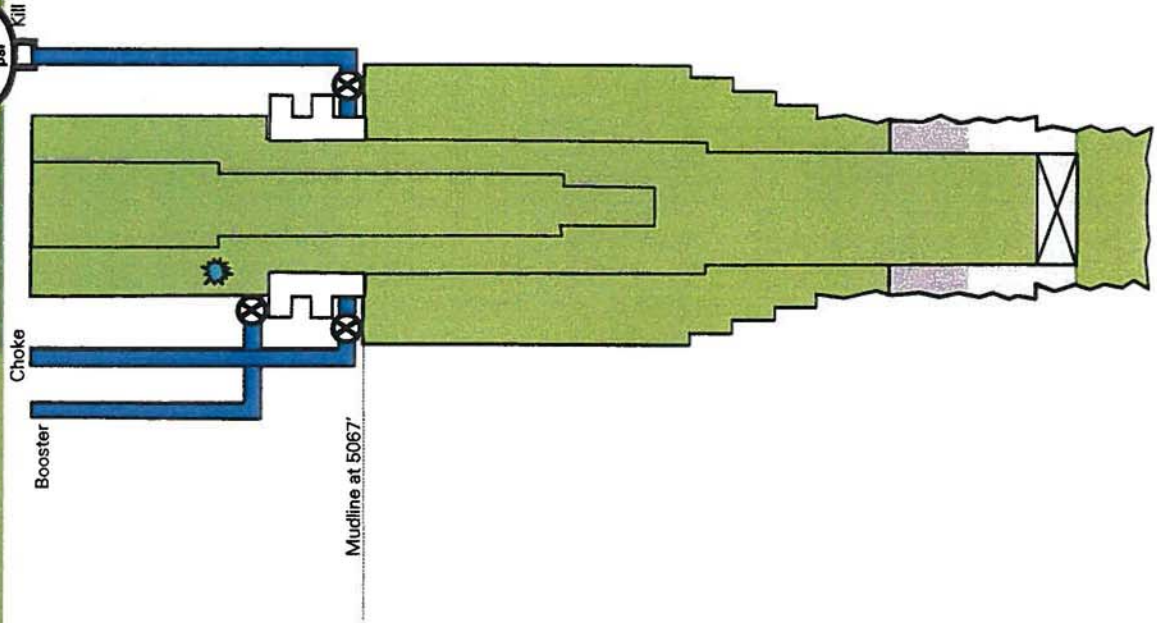
- Displaced booster line w/ seawater
- Displaced choke line with seawater
- Displaced kill line with seawater
- 1200 psi trapped in kill line

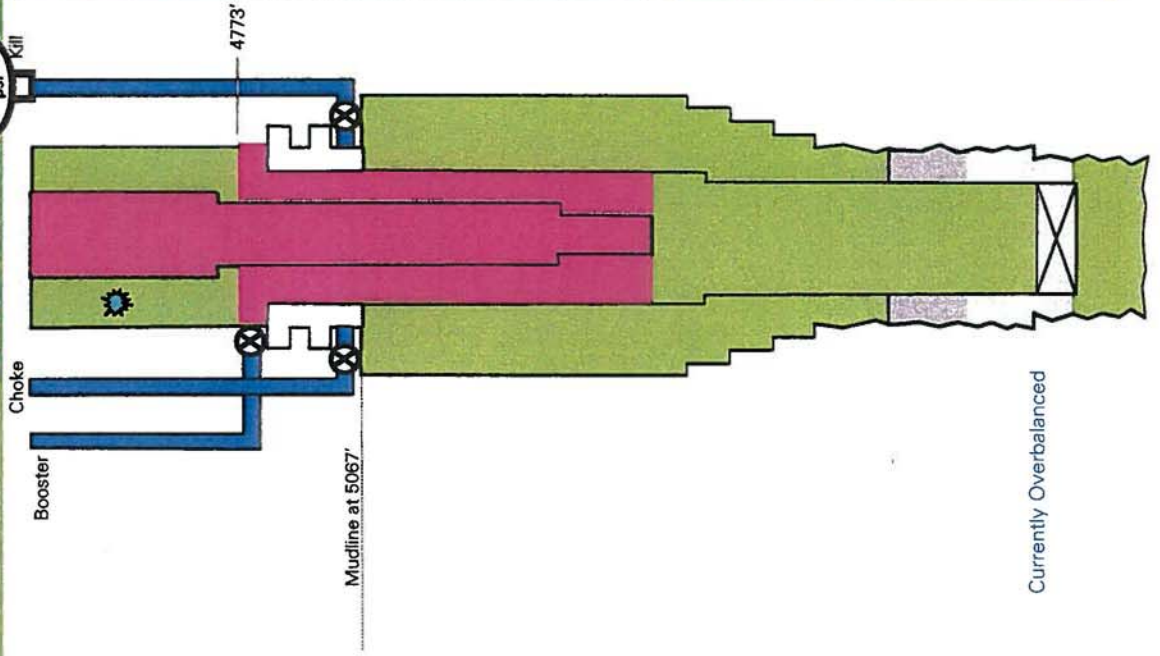
Data	
•	Pump 454 bbbls LCM spacer (16.0 ppg)
–	Form-a-Set + Form-a-Squeeze combination
–	Viscous, solids-laden fluid
•	Kill line pressure holds at 1200 psi

Interpretation	
•	Any gas from the cement job should be to surface by this point
–	No abnormal gas shows seen

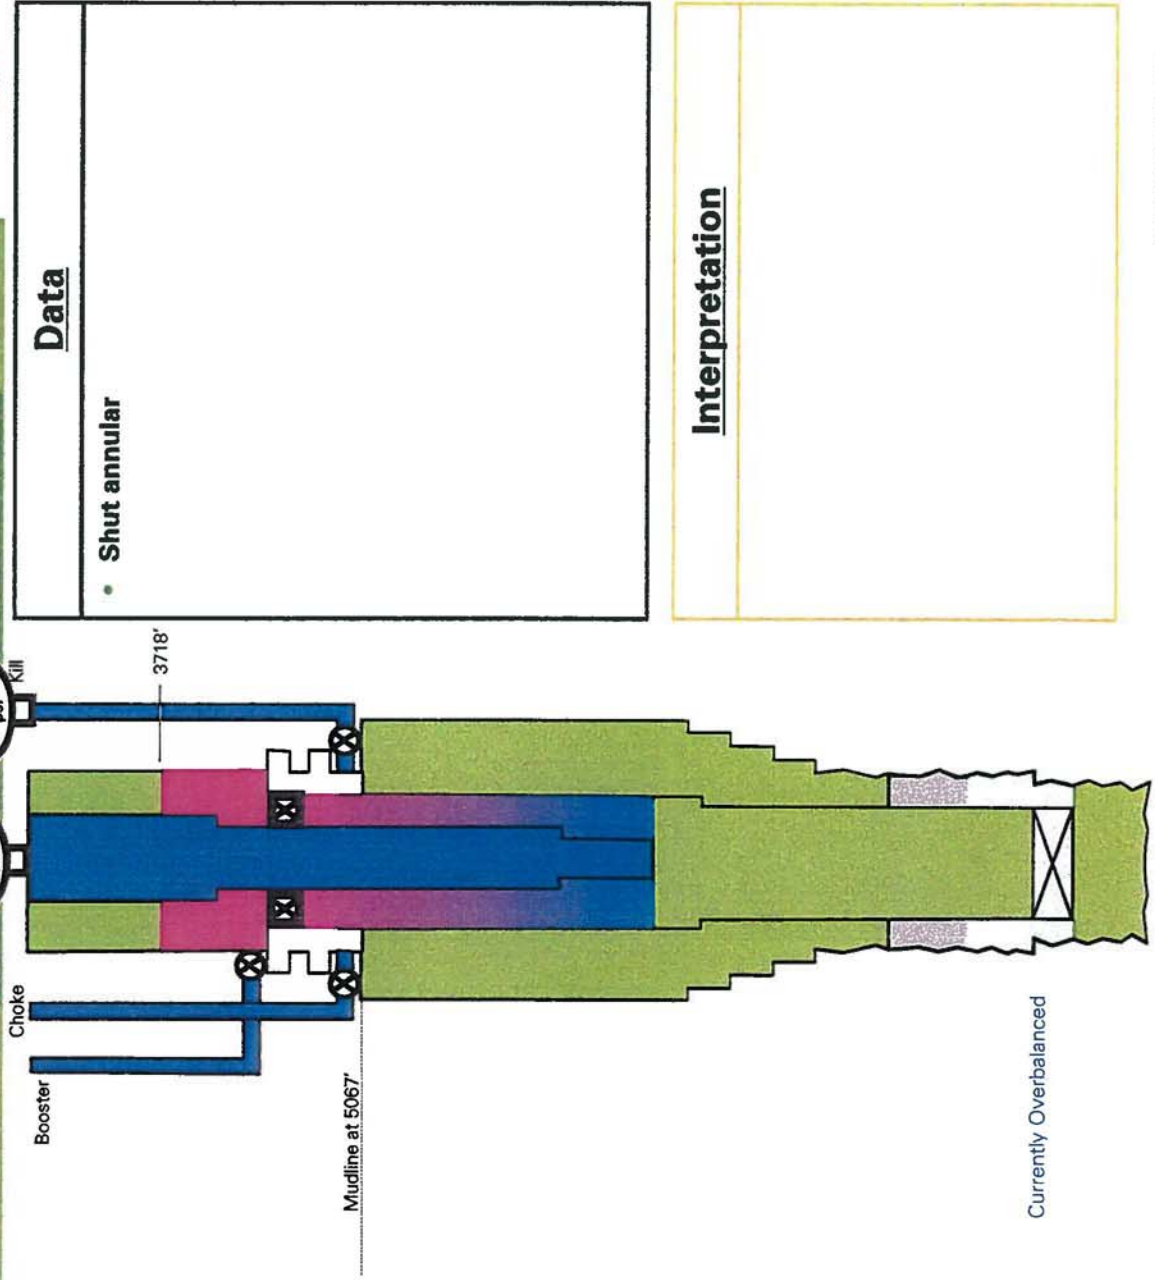
Currently Overbalanced

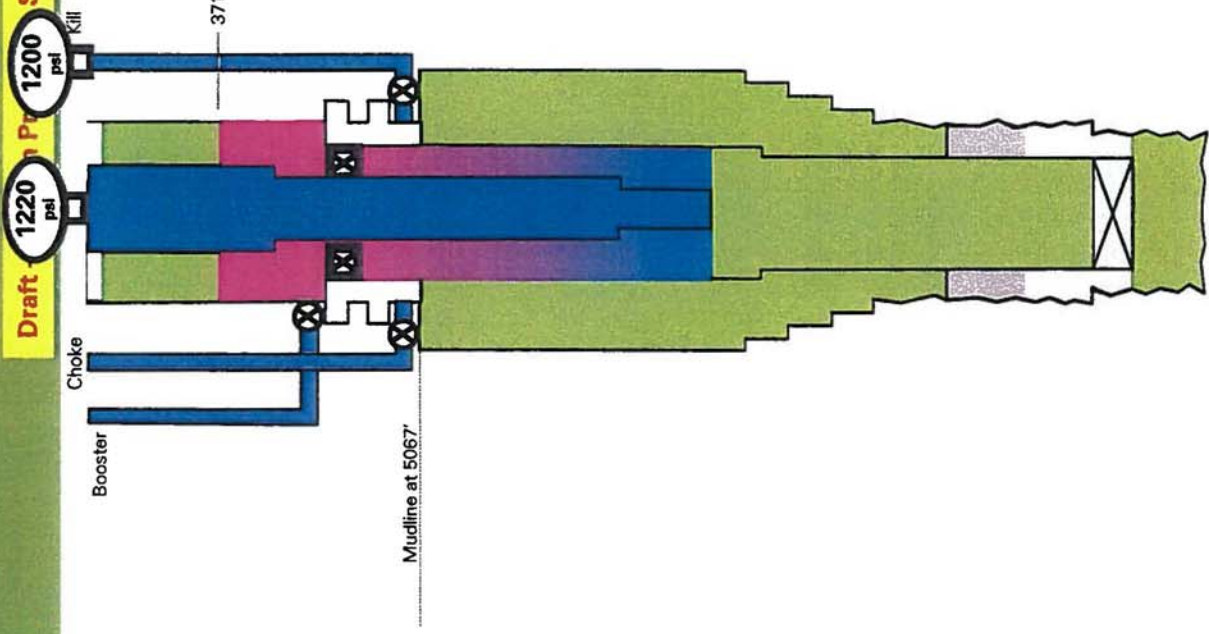
- Bleed drill pipe pressure from 2325 psi to 1220 psi to equalize with kill line

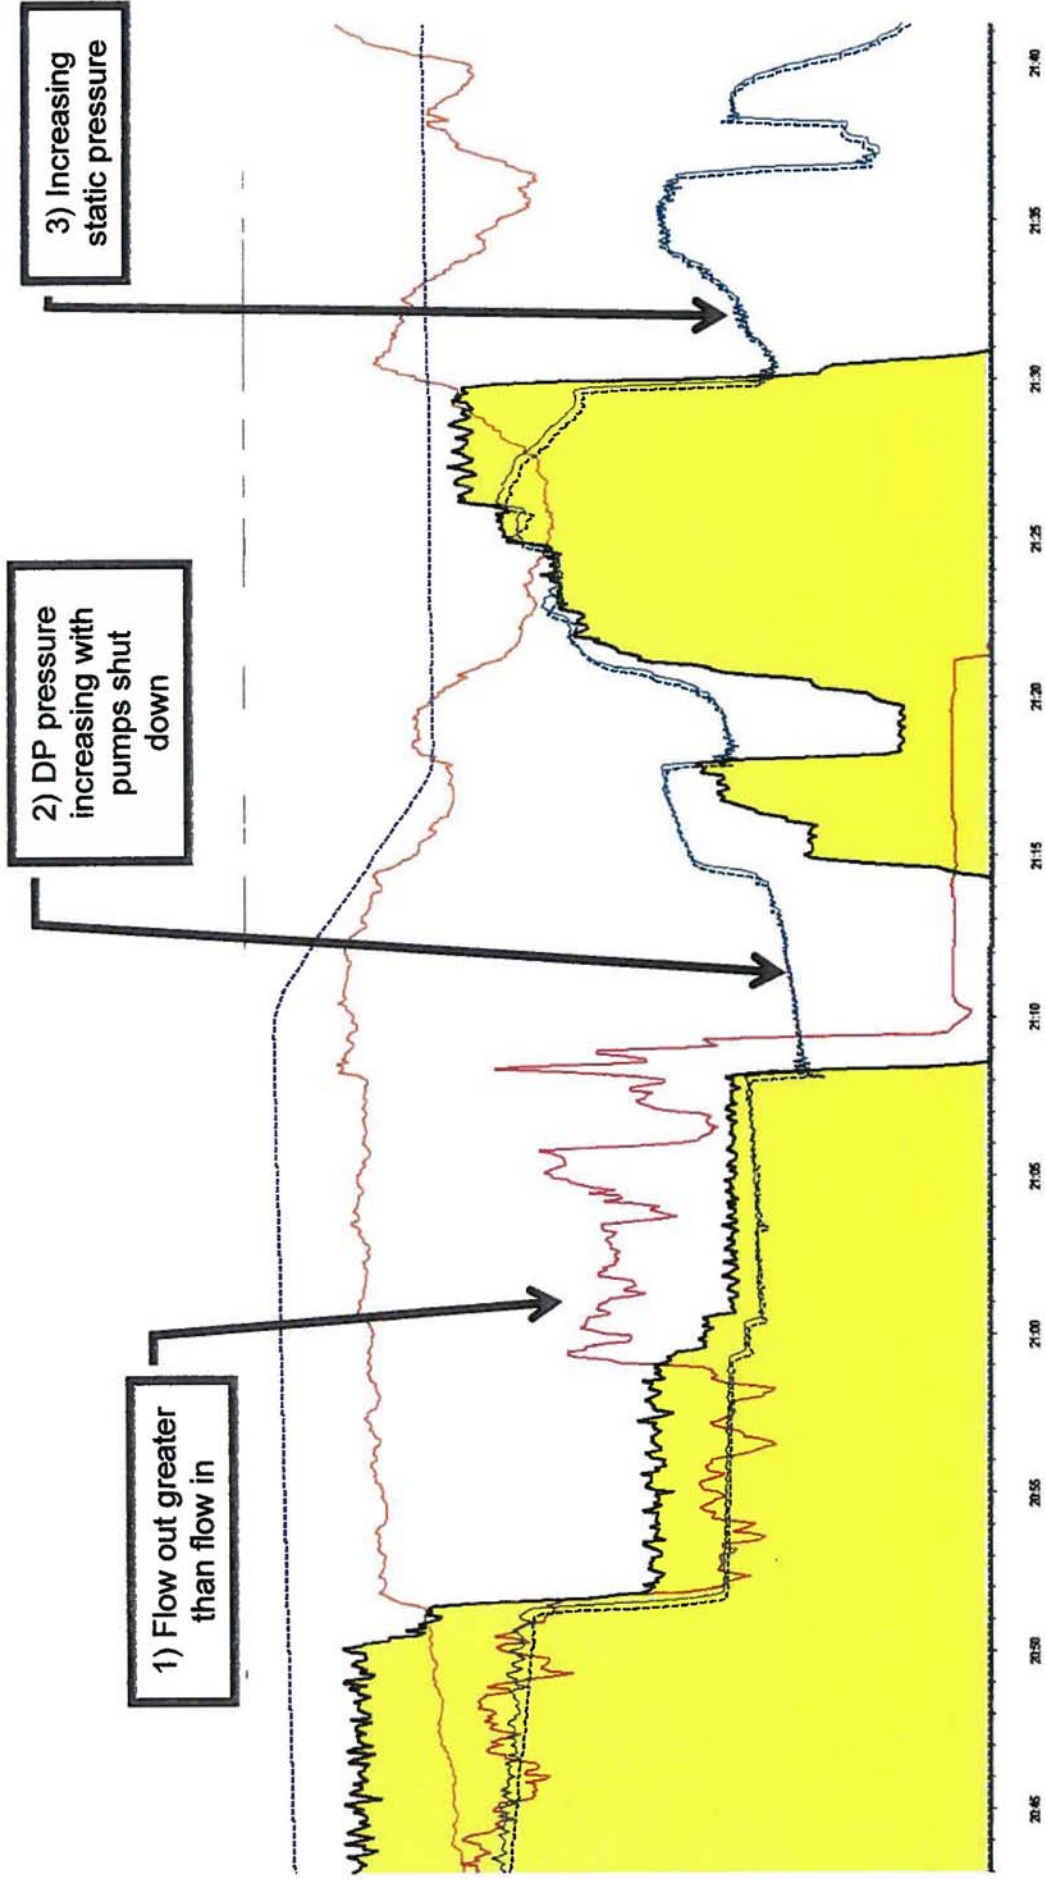
Three Flow Indicators

Critical Factor 2: Flow Indication #1 51 minutes before explosion

- At 21:08 – pump shutdown as spacer observed at surface. Sheen test required.
 - Flow-out should be zero, but real-time data indicates well flowing after pump shut off
 - Drillpipe pressure increased from 1017 psi to 1263 psi over 5.5 minute period of sheen test

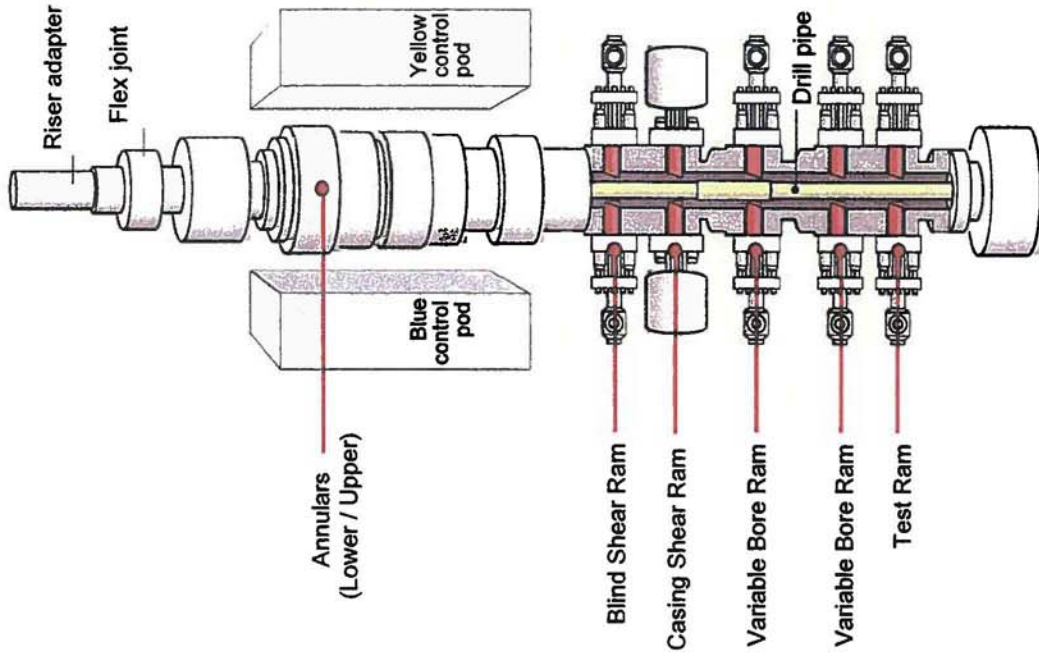
BOP Function Description

- **UAP Upper Annular Preventer** used in normal drilling operations for well shut-in rated 10K.
- **LAP Lower Annular Preventer with Casing Stripping Element..** Used for casing stripping purposes, down rated to lower wellbore retaining pressure 5K.
- **BSR Blind Shear Rams** Cuts drill pipe and seals the well.
- **CSR Casing Shear Rams Non-Sealing,** cuts drill pipe and casing; is not designed to seal the wellbore.
- **UPR Upper Pipe Rams** Ram packers can close on a range of drill pipe from 3 1/2" OD to 6 5/8" OD and seal up to 15K wellbore pressure.
- **MPR Middle Pipe Rams** Ram packers can close on a range of drill pipe from 3 1/2" OD to 6 5/8" OD and seals up to 15K wellbore pressure, can also be stripped through to hang-off drill pipe up 600K
- **LPR Lower Pipe Rams .** Test Ram seals up to 15K pressure from above.
